ULTI-AXIS

USER GUIDE VERSION 1.0d

Mark Roberts Motion Control Ltd.
Unit 4 Birches Industrial Estate,
Imberhome Lane,
East Grinstead,
West Sussex, RH19 1XZ,
England

SA-20 User Guide Version 1.0d

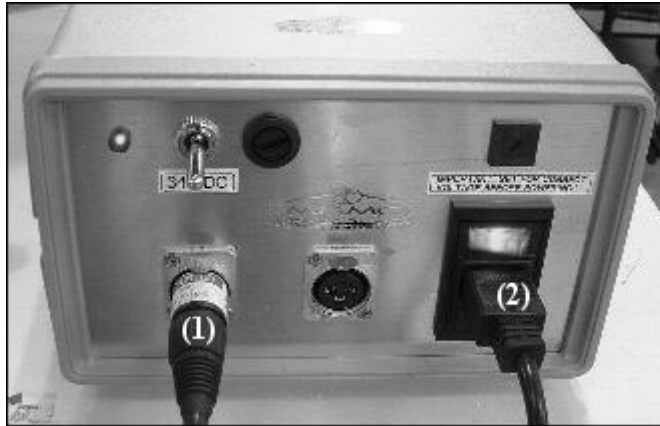
Figure 1. Power supply unit with connections.

- 1). MSA-20 power
- 2). Mains power

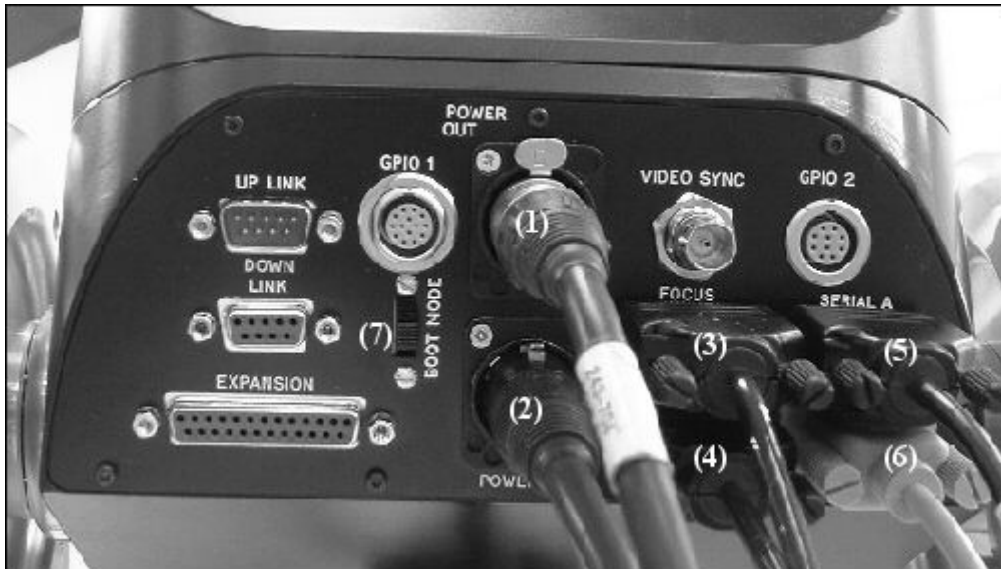
Figure 2. MSA-20 rear panel with (Standalone) connections.

- 1). Ulti-Head Slip-Ring power – optional (The head can have a separate power supply)
- 2). MSA-20 power - required
- 3). Focus pot (Wheel 4) - optional
- 4). Zoom pot (Wheel 5) - optional
- 5). Ulti-Head Slip-Ring serial - required
- 6). PC serial (For use with PC Backup Facility) - optional
- 7). The boot mode switch must be in the centre position. – required

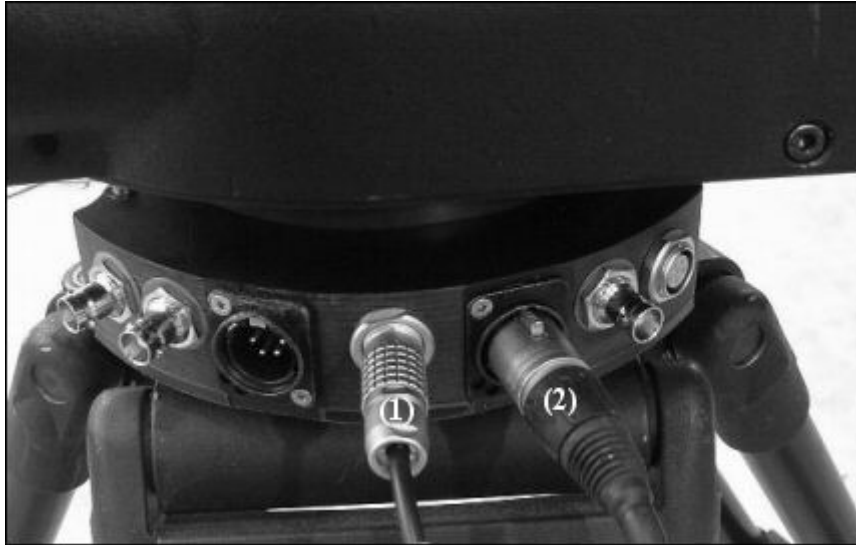
Figure 3. Ulti-Head Slip-Ring side panel with (Standalone) connections.

- 1). Ulti-Head Slip-Ring serial
- 2). Ulti-Head Slip-Ring power

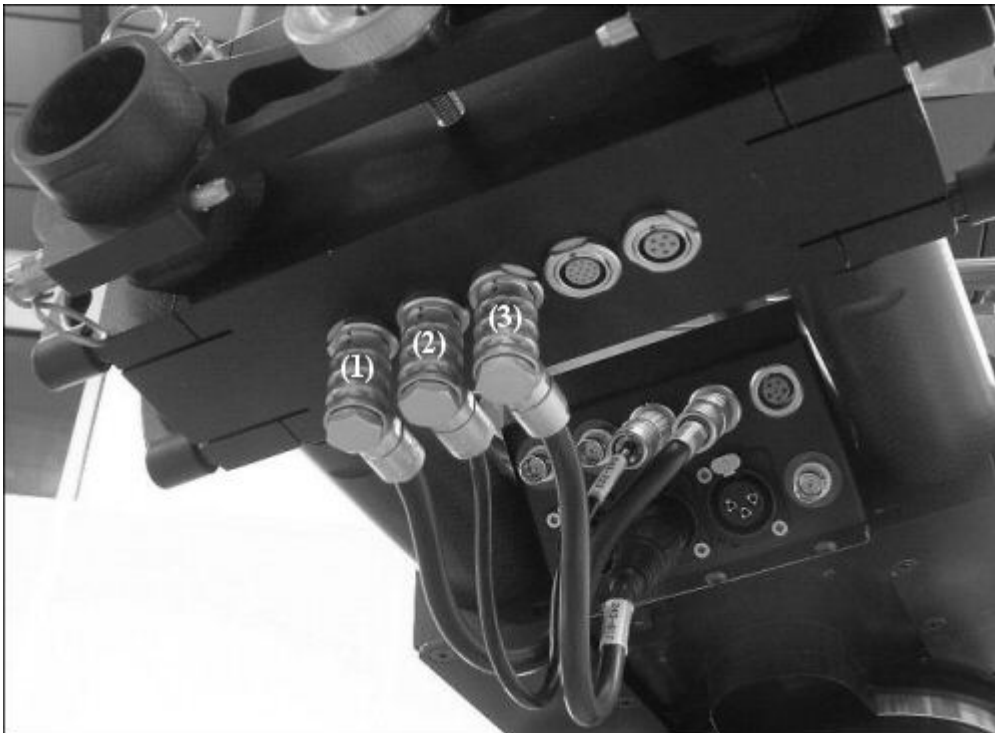
Figure 4. Ulti-Head Slip-Ring lower panel and Ulti-Head Elbow lower panel with (Standalone) connections.

- 1). Ulti-Head Slip-Ring to Ulti-Head Elbow Pan motor
- 2). Ulti-Head Slip-Ring to Ulti-Head Elbow serial
- 3). Ulti-Head Slip-Ring to Ulti-Head Elbow power

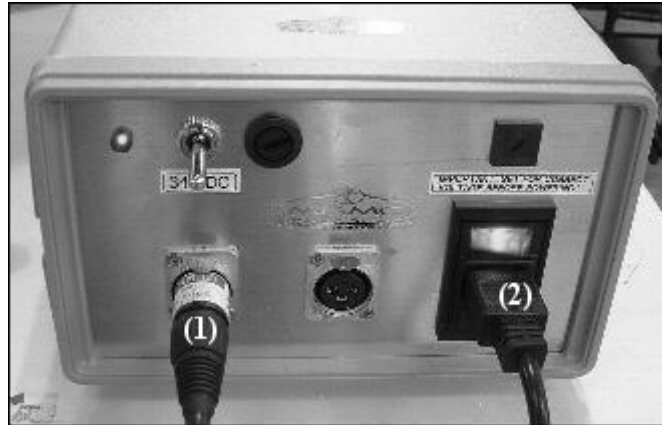
Figure 5. Power Supply Unit with connections.

- 3). MSA-20 power
- 4). Mains power

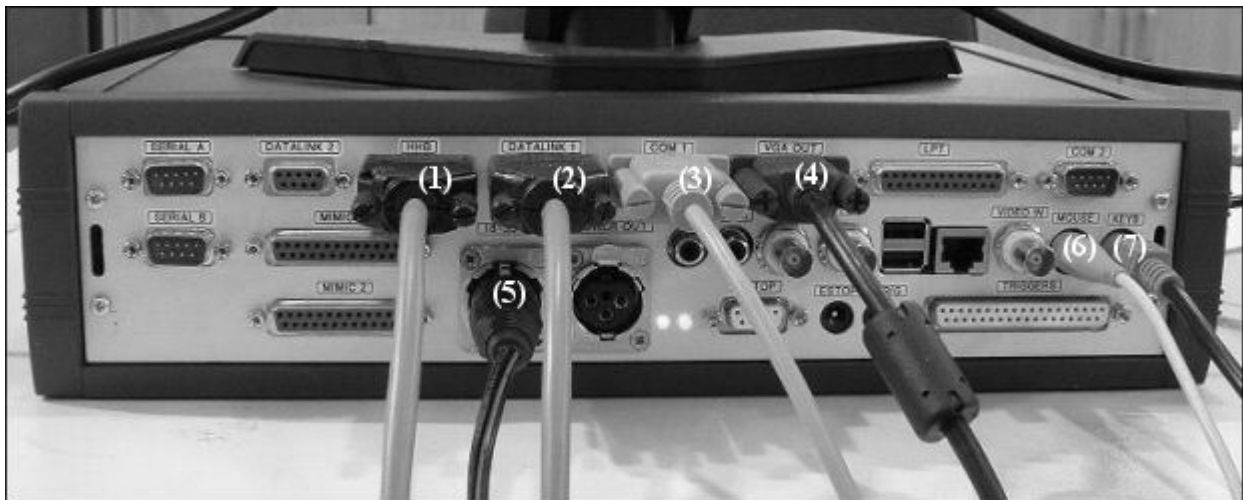
Figure 6. Rootbox rear panel with connections.

- 1). Hand Held Box datalink - optional
- 2). MSA-20 datalink - required
- 3). PC serial – optional (For use with PC Backup Facility when in standalone mode)
- 4). Monitor -required
- 5). Rootbox power - required (Connects to separate 24V rootbox power supply unit)
- 6). Mouse - required
- 7). Keyboard – required

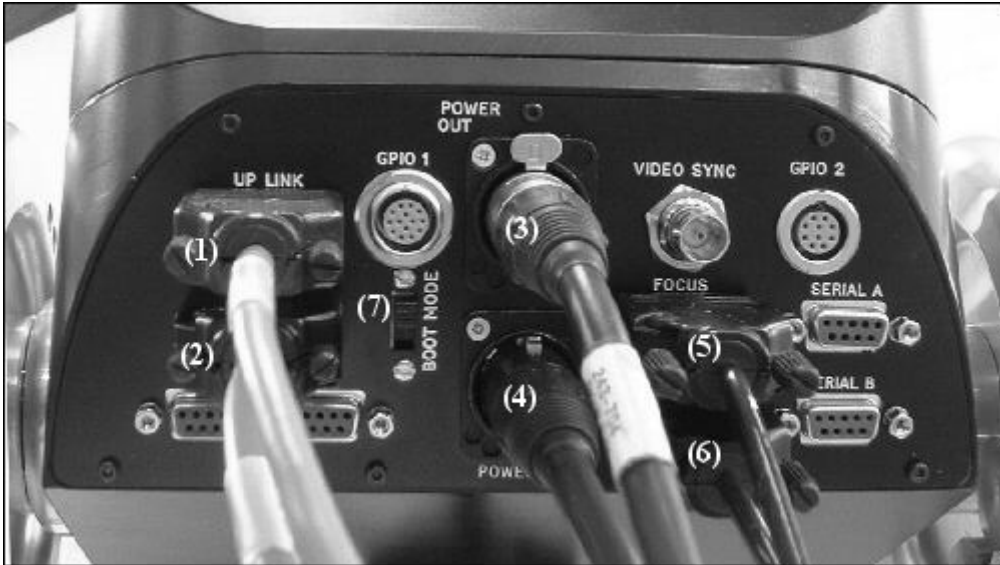
Figure 7. MSA-20 rear panel with (Flair) connections.

- 1). MSA-20 datalink - required
- 2). Ulti-Head Slip-Ring datalink -required
- 3). Ulti-Head Slip-Ring power – optional (The Ulti-Head can have a separate power supply)
- 4). MSA-20 power - required
- 5). Focus pot (Wheel 4) - optional
- 6). Zoom pot (Wheel 5) - optional
- 7). The boot mode switch must be in the upper position - required

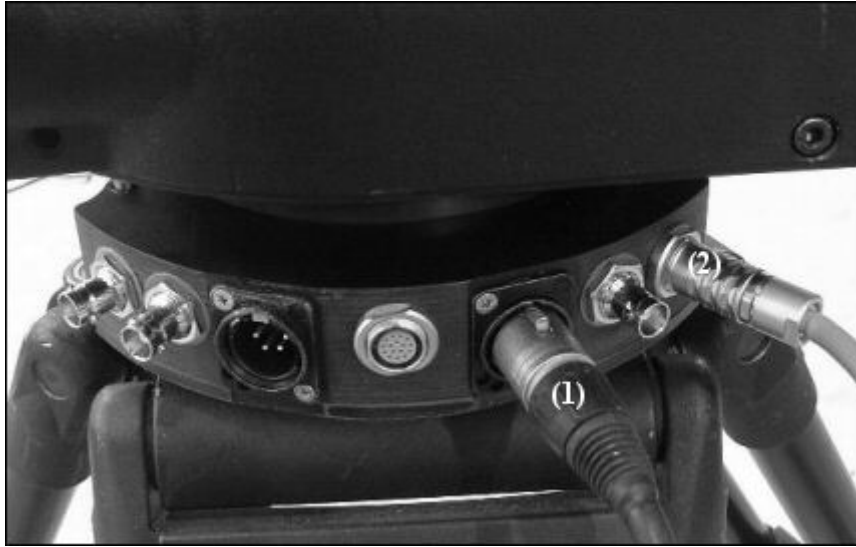
Figure 8. Ulti-Head Slip-Ring side panel with (Flair) connections.

- 1). Ulti-Head Slip-Ring power
- 2). Ulti-Head Slip-Ring datalink

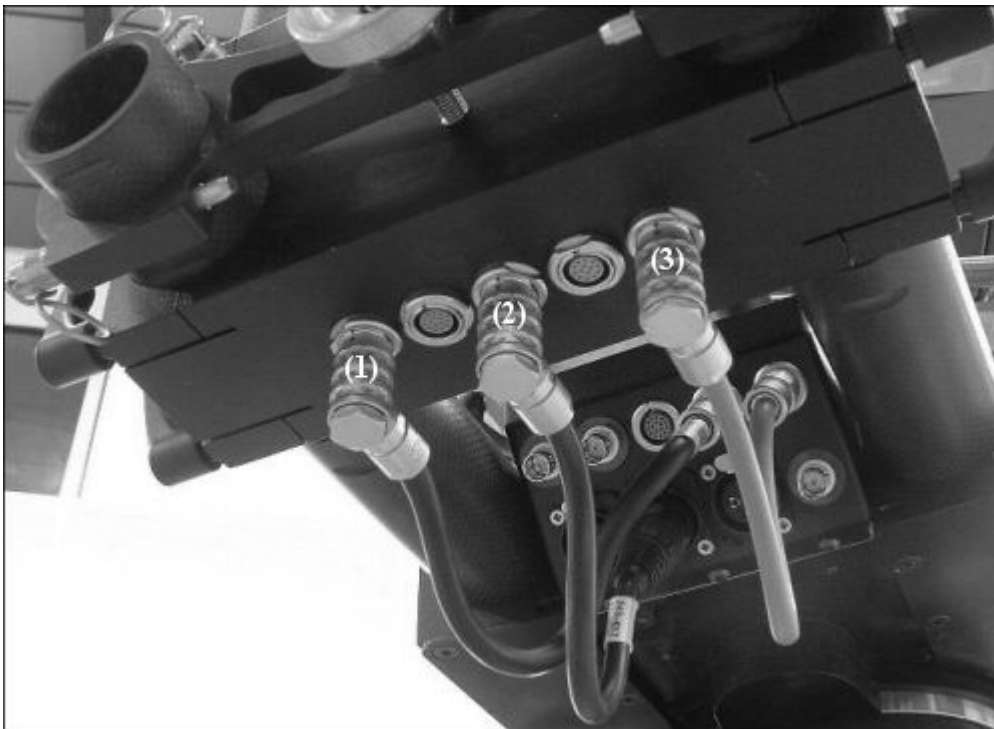
Figure 9. Ulti-Head Slip-Ring lower panel and Ulti-Head Elbow lower panel with (Flair) connections.

- 1). Ulti-Head Slip-Ring to Ulti-Head Elbow Pan motor
- 2). Ulti-Head Slip-Ring to Ulti-Head Elbow power
- 3). Ulti-Head Slip-Ring to Ulti-Head Elbow datalink

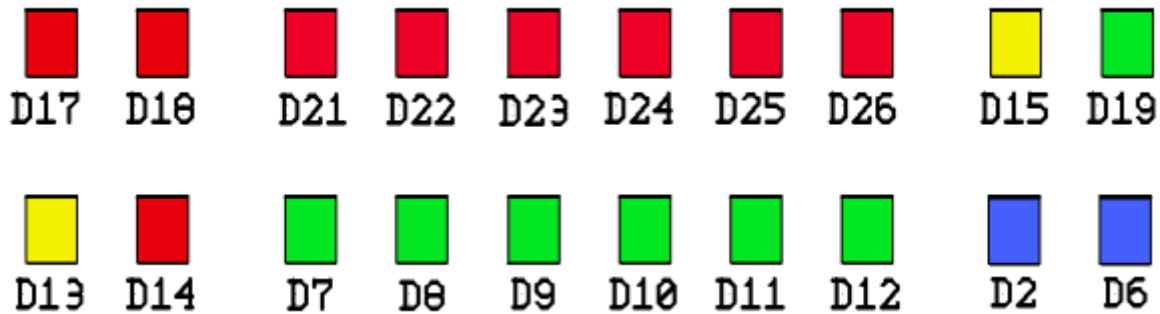
The LEDs all have water clear lenses and so the colour is not apparent until illuminated.

Figure 10. Ulti-Axis LEDs.

1. D17 – Up Link Fail (on)
2. D18 – Down Link Fail (on)
3. D14 – Board ID incorrect (continuous) and no watchdog (flashing 1Hz)

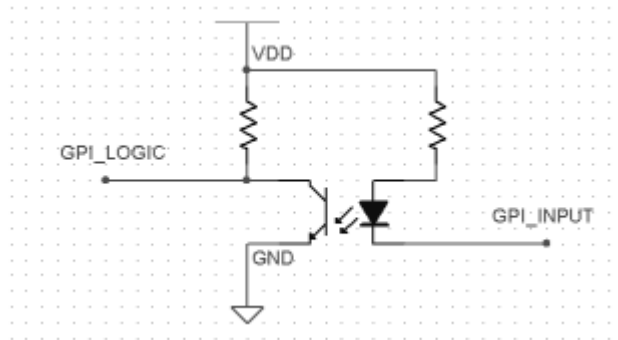
Figure 11. General Purpose Input.

Absolute Maximum Ratings:

I Max: 50mA

All the general purpose outputs on the MSA-20 and Ulti-Head are optically isolated open-collector logic. All the general purpose inputs on the MSA-20 and Ulti-Head are open-cathode logic.
